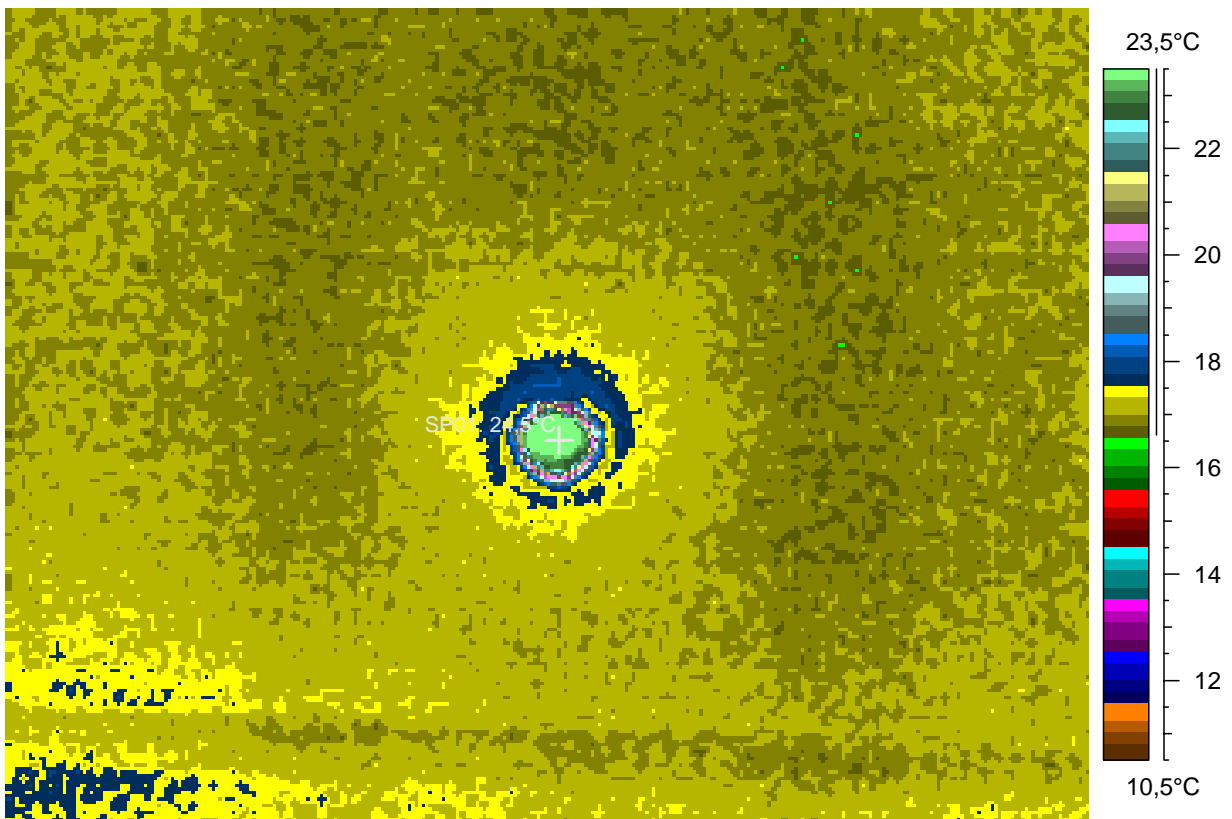
1 - Ir\_1488.jpg

LED light detail, above the corridor floor

Label	Value
IR : max	24,8°C
IR : min	16,5°C
SP01	24,5°C

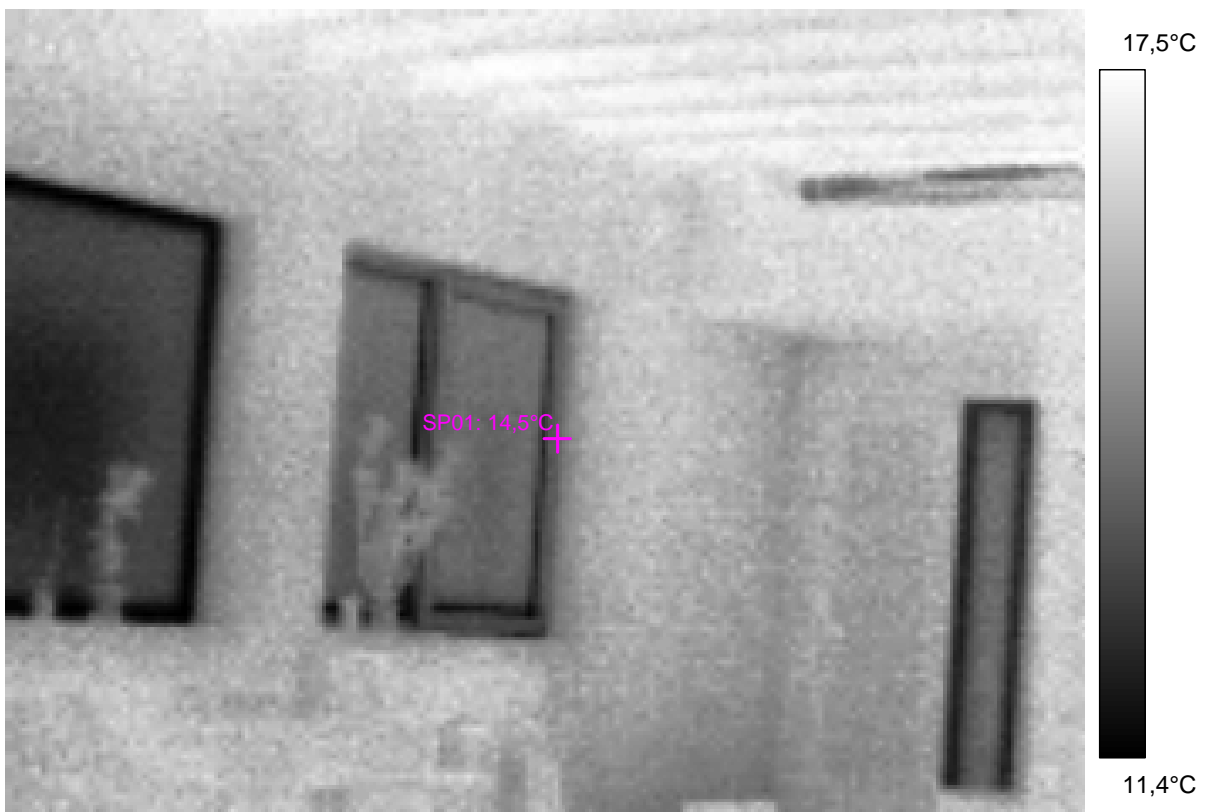
## 5 - Ir\_1492.jpg

NW corner of the lecture hall, entrance door at right, foyer glazing to the buffer zone visible a bit. Fixed glass at left.

Label	Value
IR : max	17,7°C
IR : min	11,0°C
SP01	14,5°C

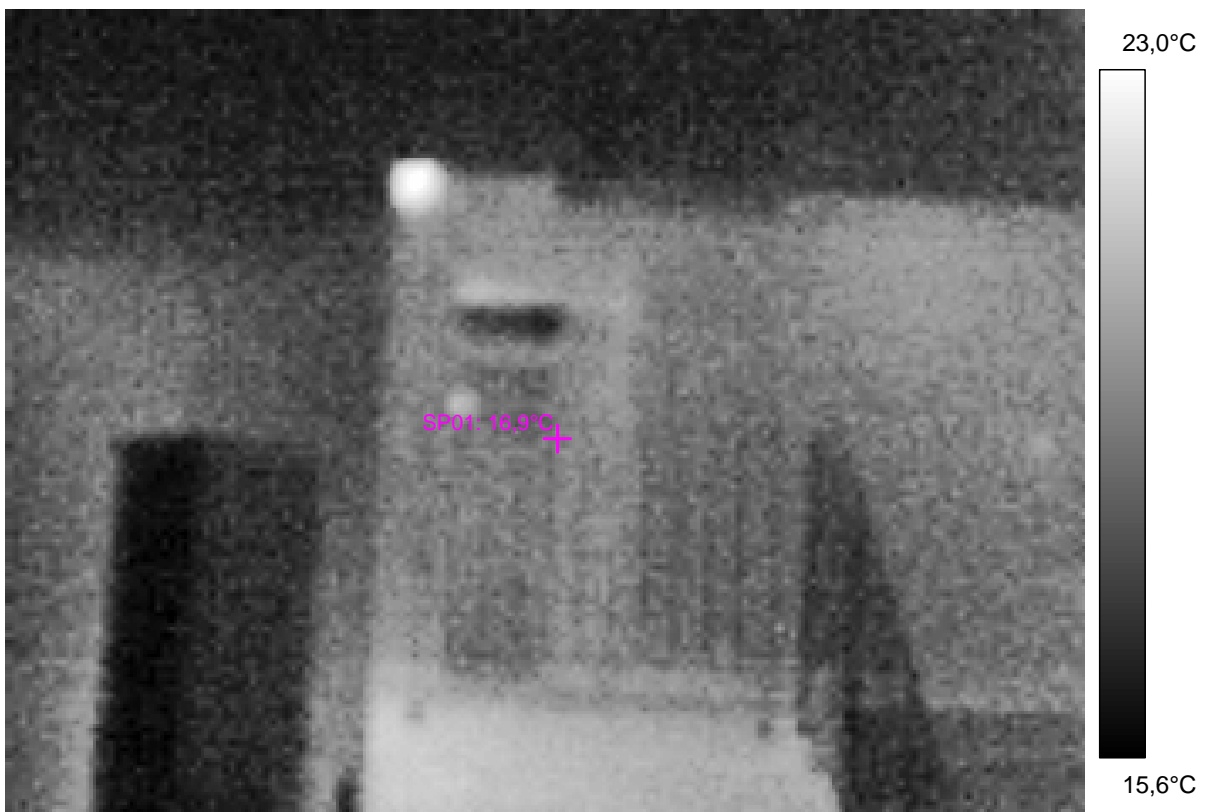
## 11 - Ir\_1498.jpg

N part of the foyer. Adobe wall at left with a wooden box in front of it, staircase and door to dormitory at right.

Label	Value
IR : max	24,1°C
IR : min	15,5°C
SP01	16,9°C

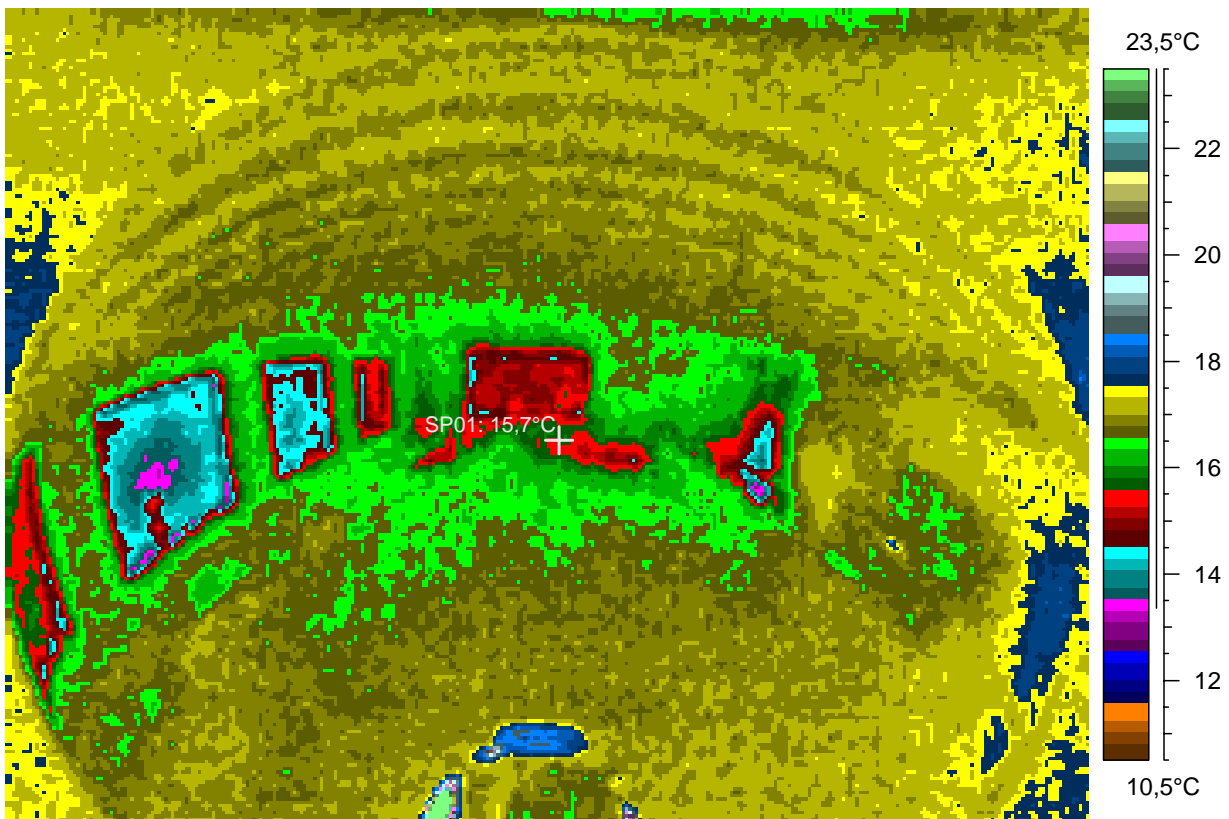
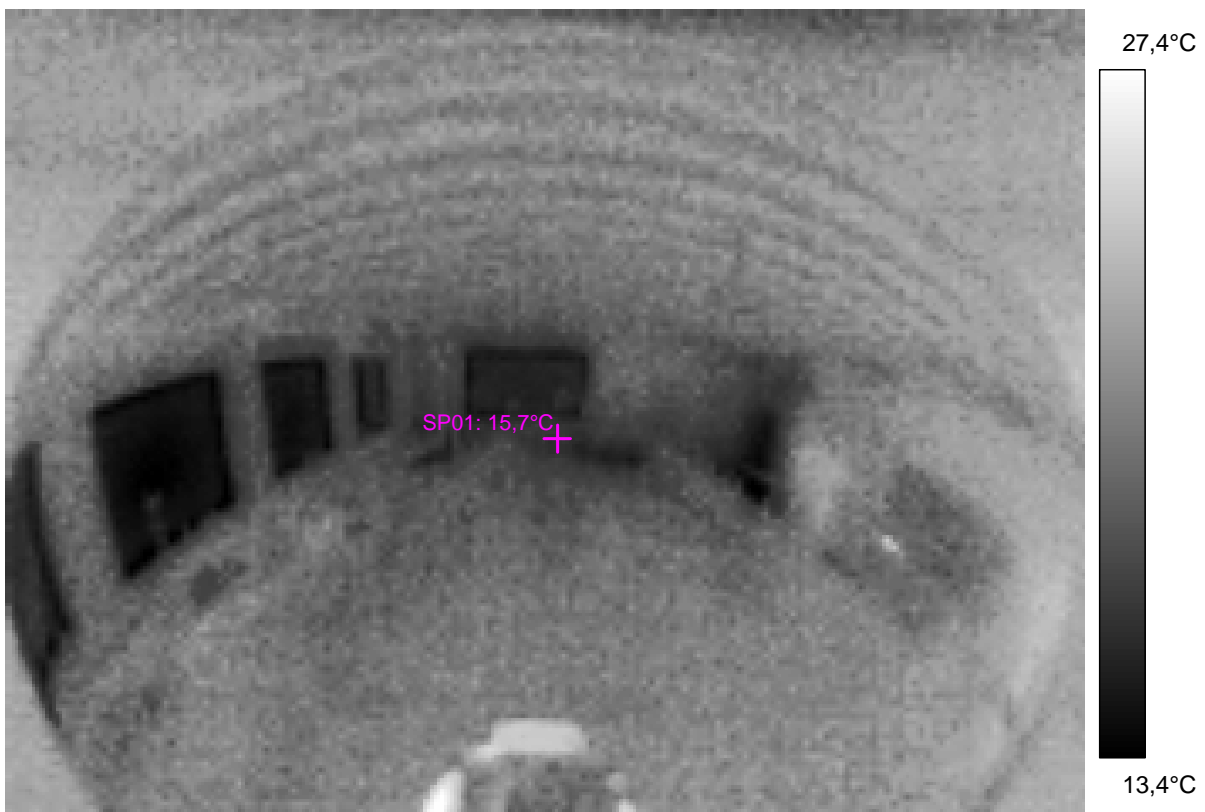
22 - Ir\_1509.jpg

mirror view of lecture hall, viewed from the screen southwards

Label	Value
IR : max	28,8°C
IR : min	13,1°C
SP01	15,7°C
