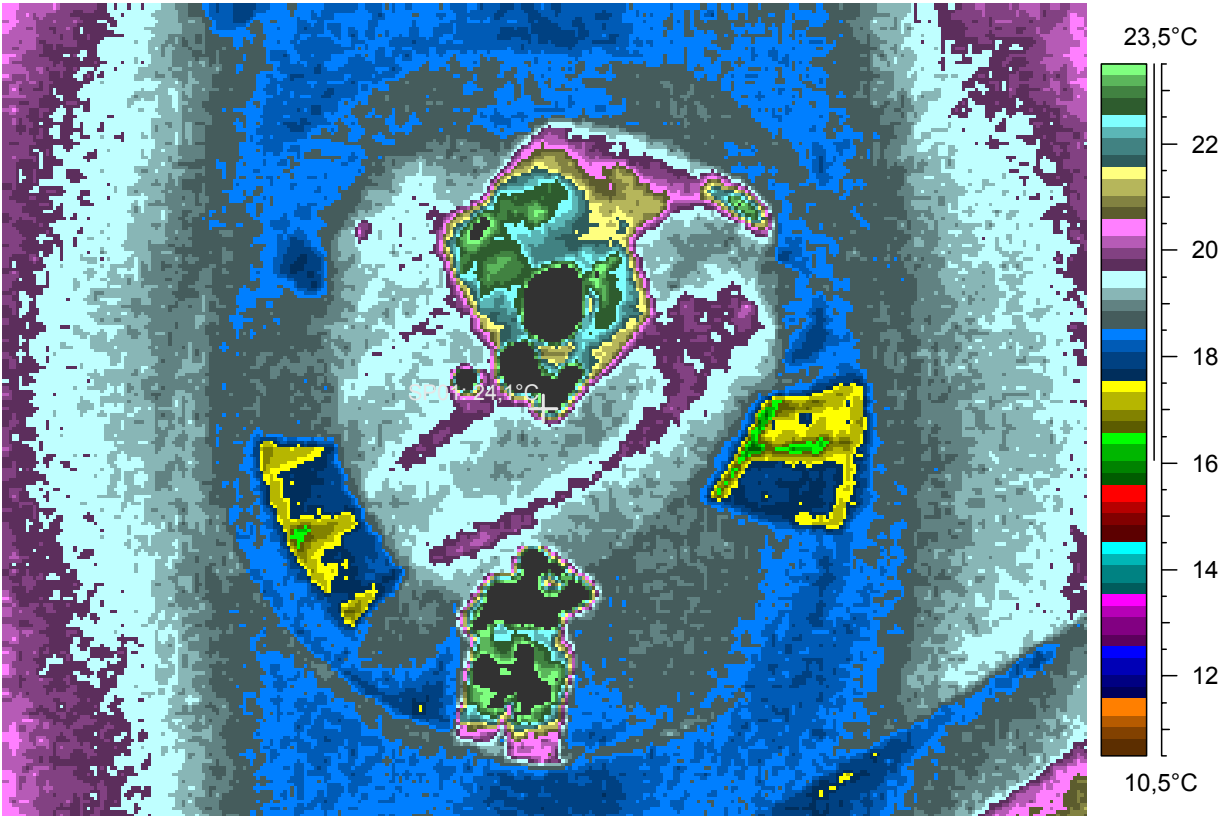
1 - Ir_1561.jpg

Ceiling mirrored in an aluminized condenser lens. The logs are apparent probably thanks to their heat capacity. Photographer with camera is the warm feature, another person stands nearby.

Label	Value
IR : max	33,1°C
IR : min	15,6°C
SP01	24,1°C

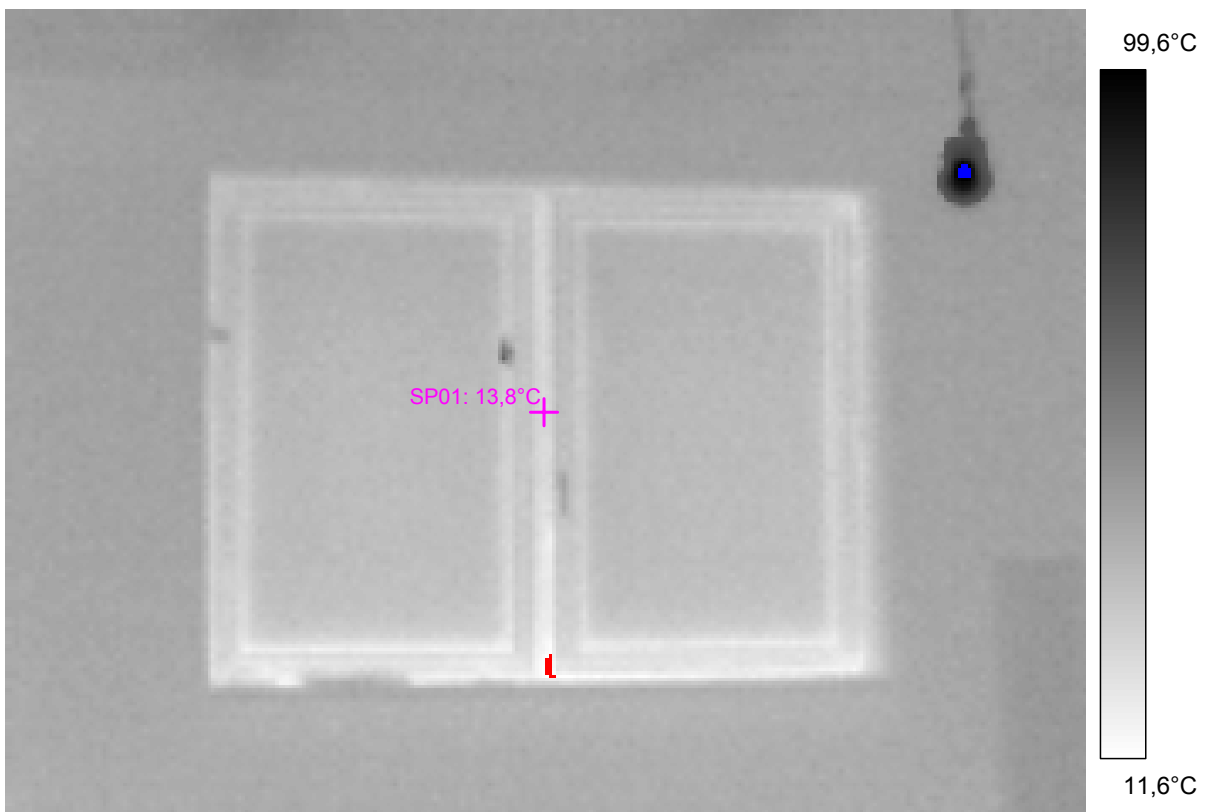
2 - Ir_1562.jpg

A bare bulb is the hot spot. Draft along the (tight)window is apparent from the lower temperature just below it. 17 Celsius seems to be an equilibrium temperature. Pane is just 2 K colder.

Label	Value
IR : max	118,6°C
IR : min	11,0°C
SP01	13,8°C

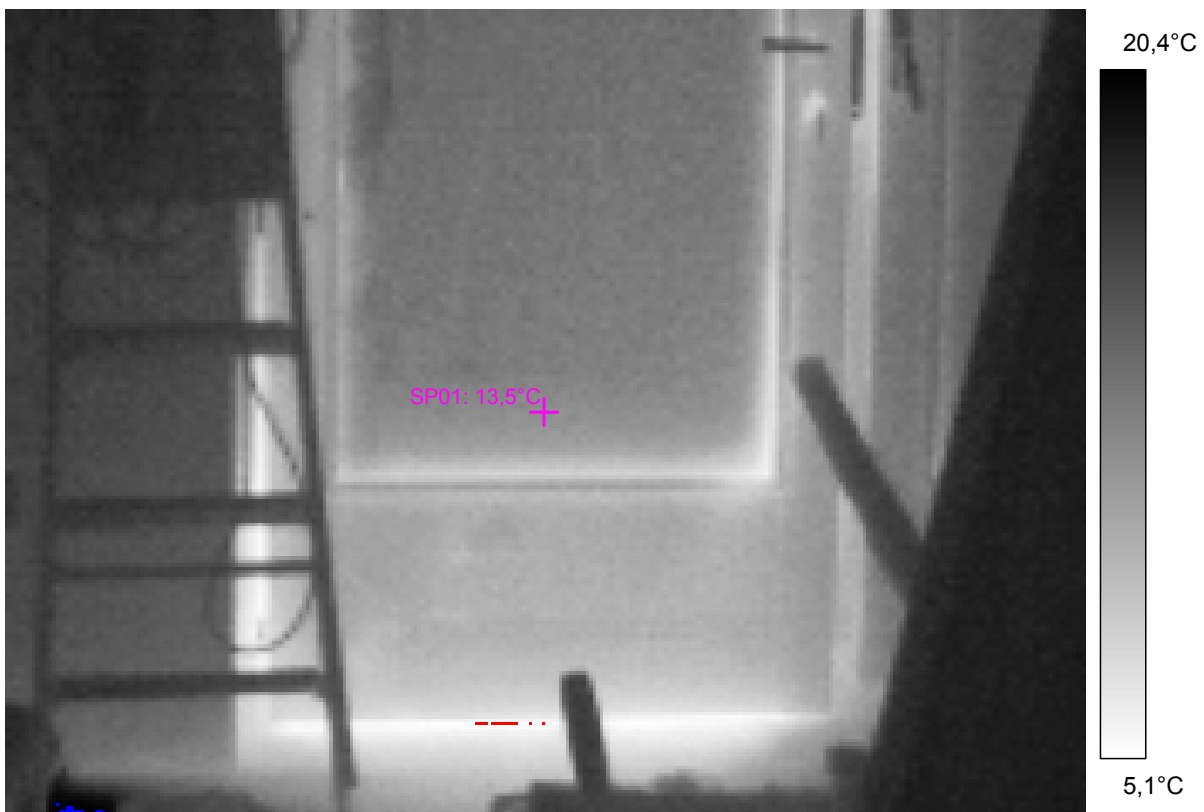
3 - Ir_1563.jpg

Drafts through the eastern door are apparent (the door has been damaged by a thief several times). This part will be improved.

Label	Value
IR : max	20,8°C
IR : min	4,8°C
SP01	13,5°C

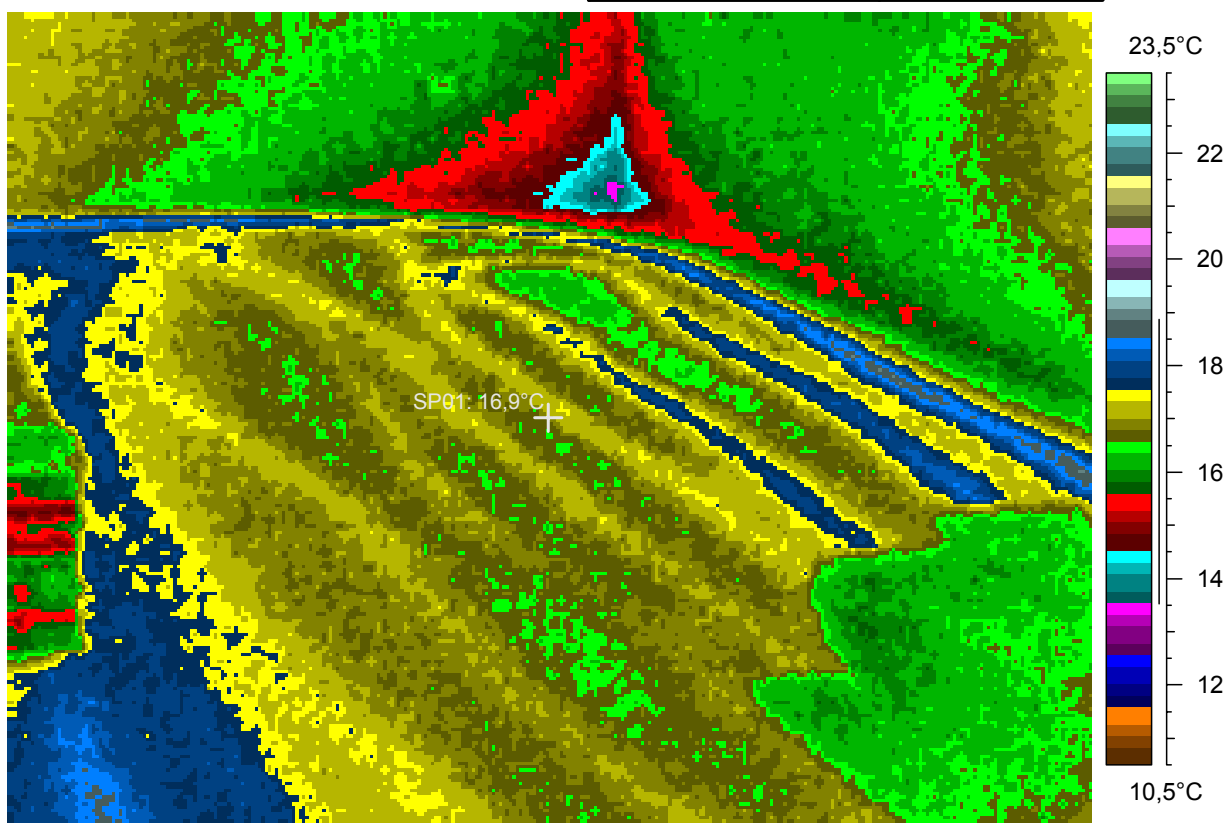
7 - Ir_1567.jpg

A geometric heat bridge at the corner, some 3.5 K colder than a wall far from it.

Label	Value
IR : max	19,1°C
IR : min	13,4°C
SP01	16,9°C

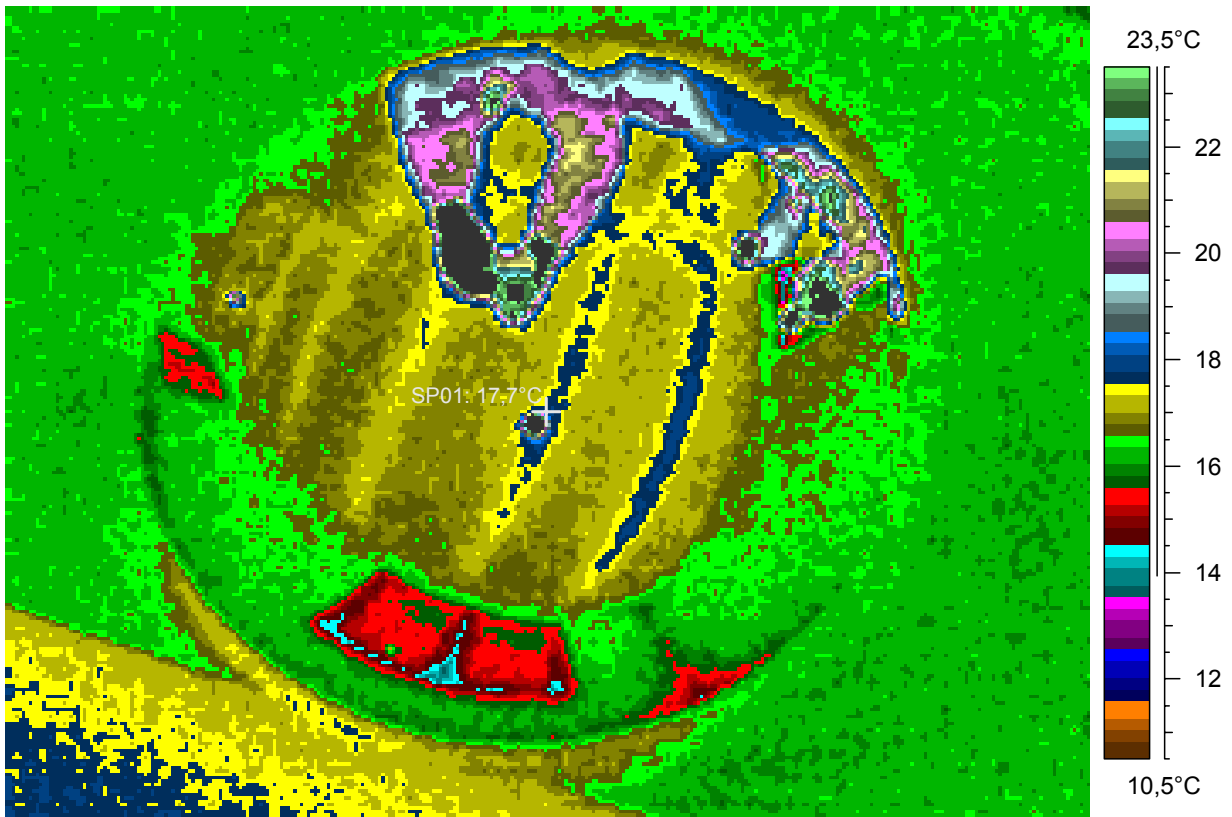
9 - Ir_1569.jpg

Ceiling, once more, in a condensor lens. Jura and Yvonna are shown too.

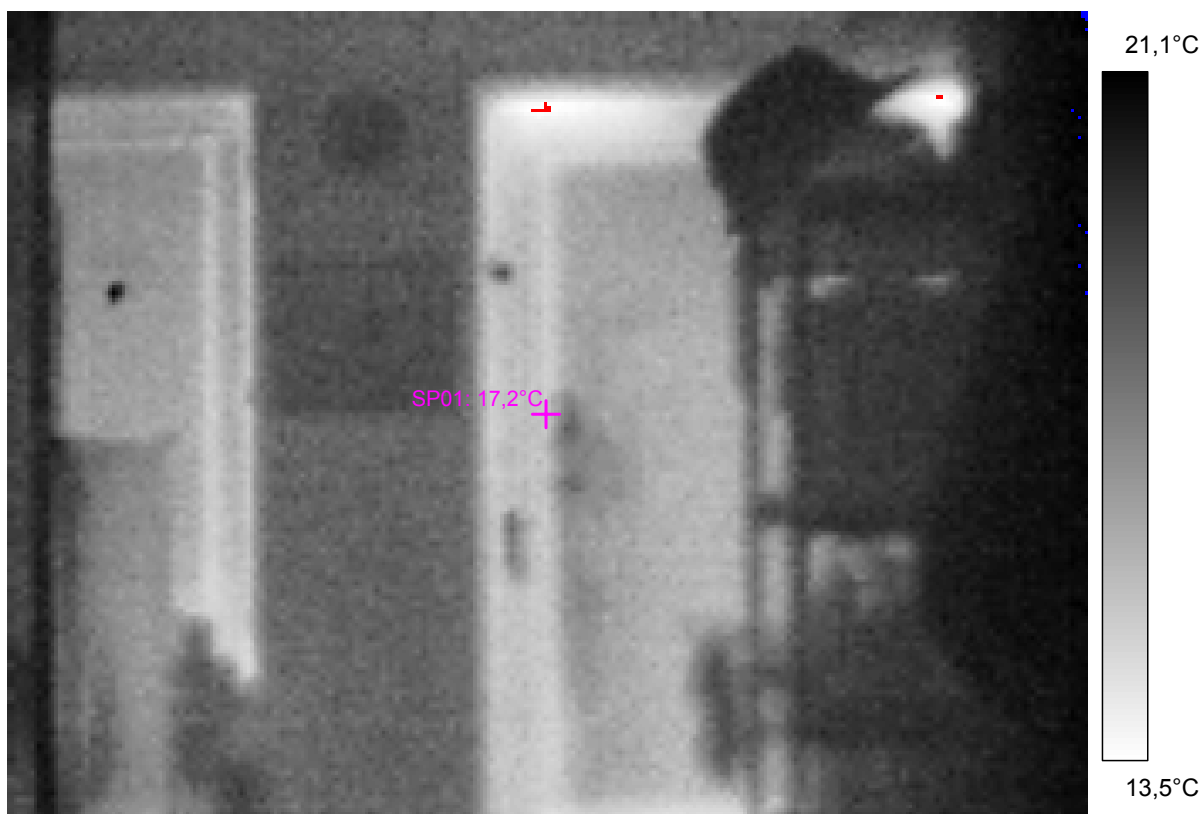
16 - Ir_1582.jpg

Windows in an inhabited flat. A bad seal (not pressed enough perhaps) is visible.

Label	Value
IR : max	21,2°C
IR : min	13,3°C
SP01	17,2°C

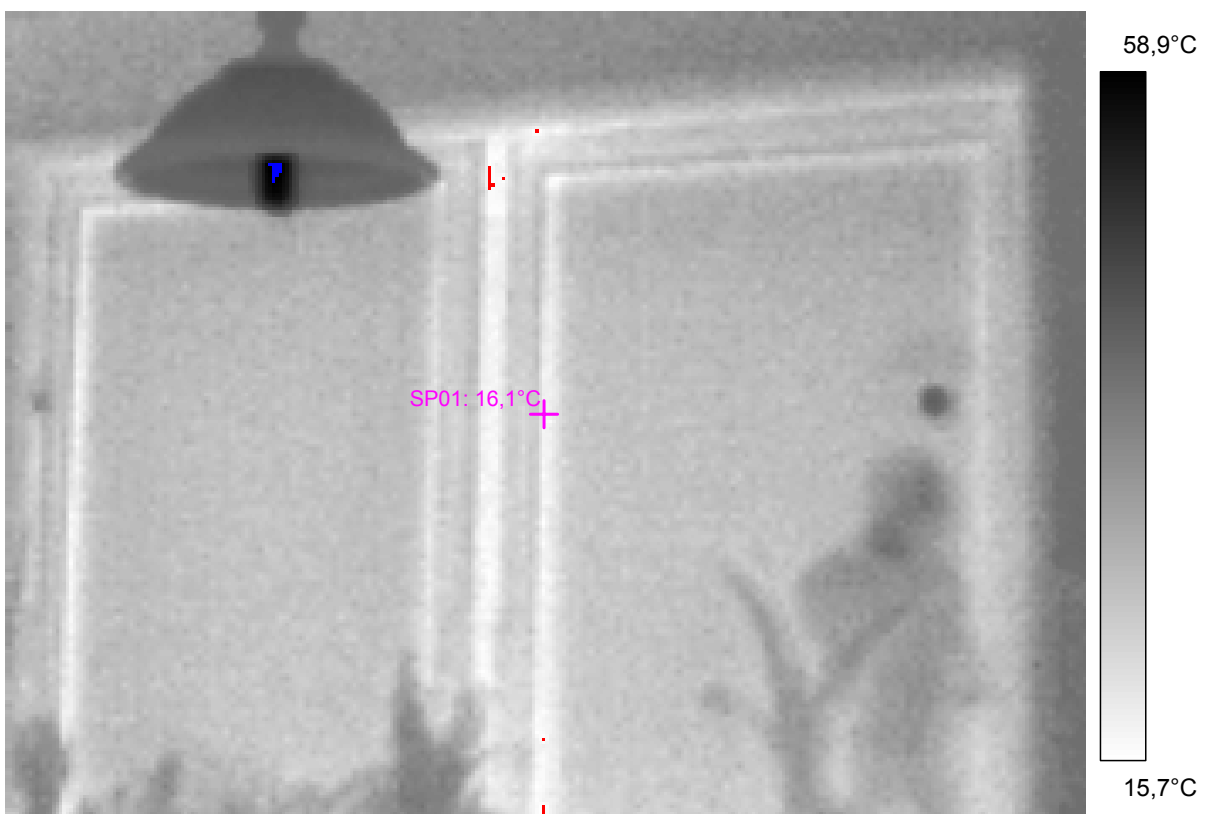
18 - Ir_1584.jpg

Window panes are just 2 K colder than walls (and 3 K then the air).

Label	Value
IR : max	62,2°C
IR : min	15,5°C
SP01	16,1°C

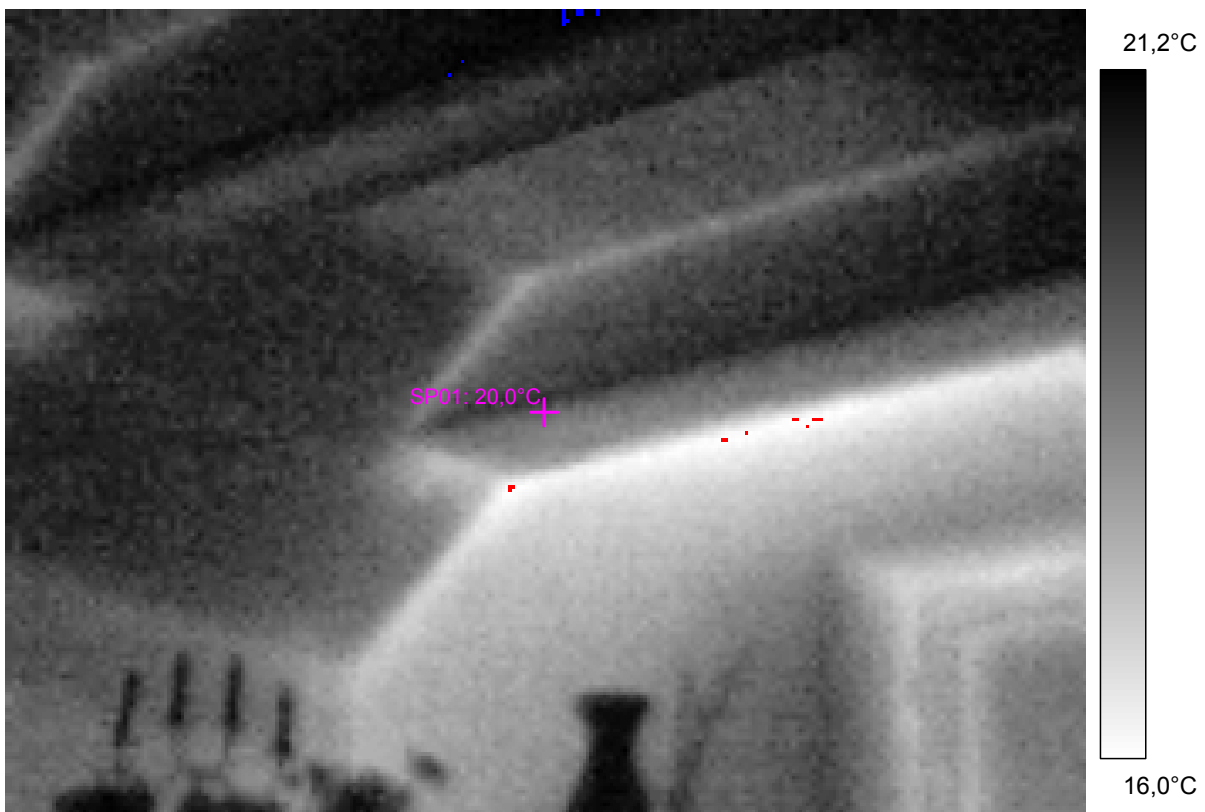
22 - Ir_1588.jpg

Heat bridges toward the roofspace, perhaps just geometric ones.

Label	Value
IR : max	21,3°C
IR : min	15,9°C
SP01	20,0°C

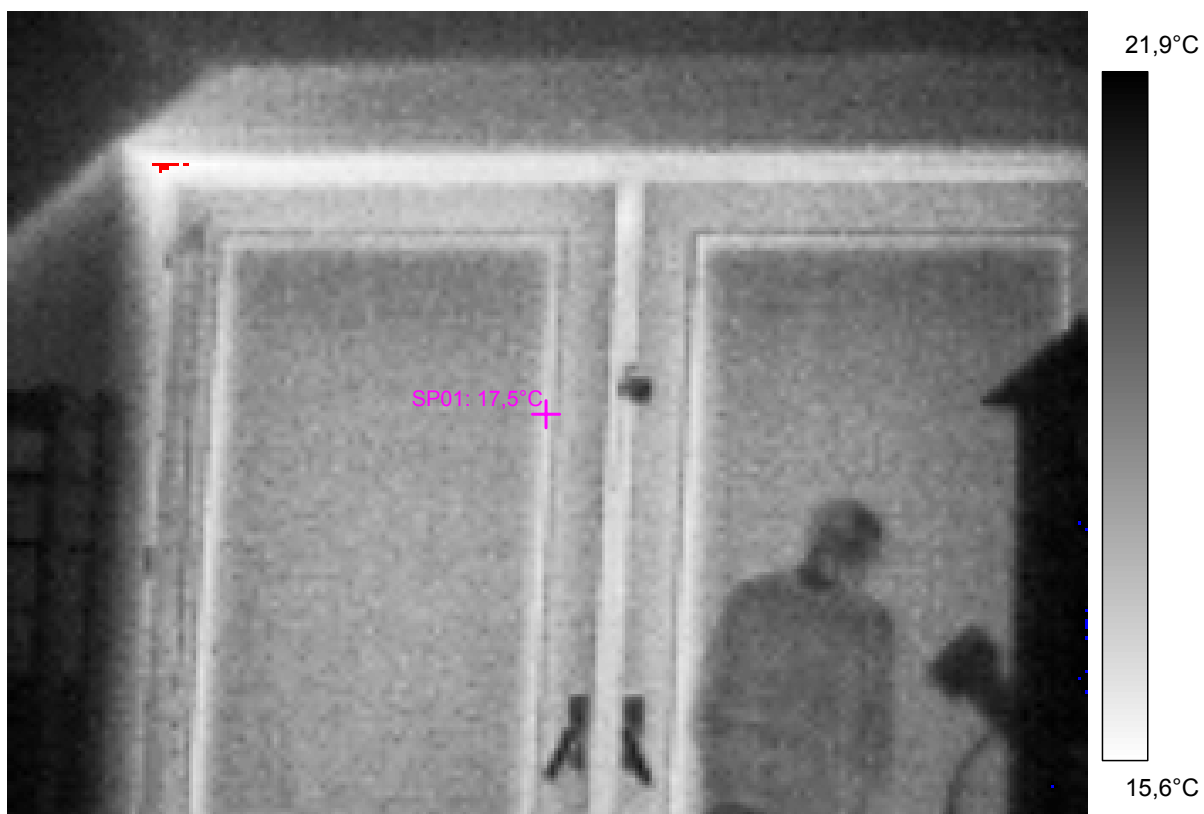
23 - Ir_1591.jpg

A slight draft at the upper left window corner. Pane is 3 K colder than the air.

Label	Value
IR : max	22,1°C
IR : min	15,3°C
SP01	17,5°C

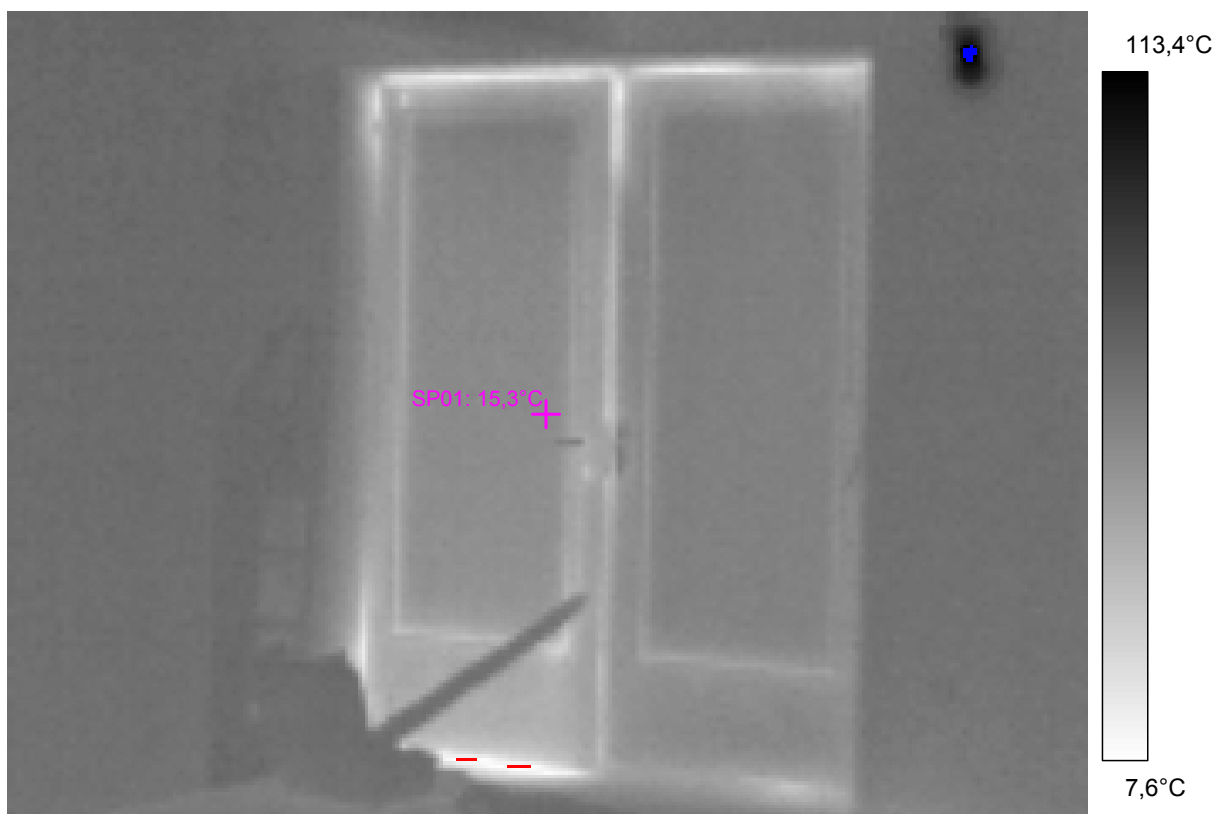
27 - Ir_1596.jpg

Eastern door, second floor.

Label	Value
IR : max	137,5°C
IR : min	6,8°C
SP01	15,3°C
