The Effects of Plastered Skin Confinement on the Performance of Straw Bale Wall Systems

Adrienne Wheeler, David Riley and Thomas Boothby
Pennsylvania State University

Summer Research Opportunities Program 2004

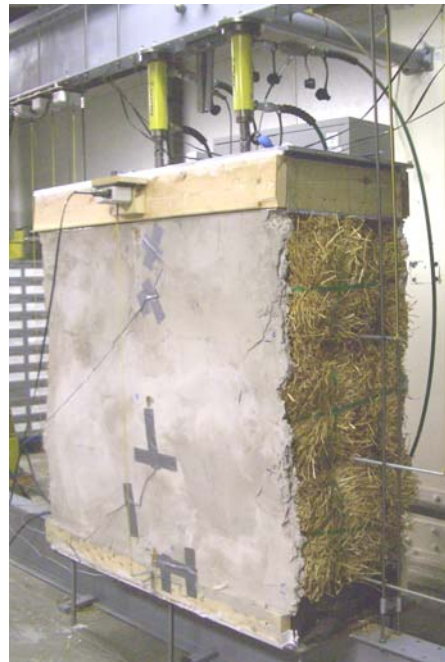
Figure 4.2- Unconfined(a) and Confined(b) test specimens

Laboratory test conducted by David Riley and students in 2003-2004, at Pennsylvania State University, showed some of the benefits to confining plaster skins. In this program, they tested walls with moderately confined skins and walls with completely confined skins. The test specimens were four feet long three bales high plastered straw walls. The bales were pinned with rebar, sandwiched in 17-gauge wire mesh using pins, and plastered with cement stucco. Each wall had top and bottom box beams placed on them that were strapped to the bales with polypropylene strapping. On the top of the upper box beam laid a steel plate to evenly distribute the load to the bales. The entire specimen rested on a bottom plate that had threaded rods connected to the floor. The stucco was confined with Z-channel on the top of the skin and J-channel on the bottom. The confined specimen had additional 2x6 and 2x4 battens along the top and bottom of the plaster skins (Figure 4.2a). The other specimen did not have the extra batten on the bottom of the skins for support (Figure 4.2b), so the skins rested solely on the J-channel. Two 20 kip hydraulic pumps electronically applied the load pressure to the walls. Both specimens under went compression tests. The testing frame to which the specimens were hooked up comprised of the potentiometers three along either side and two, front and back. Strain gauges were also placed vertically along the front and backside of the wall.

During the compression test with moderate confinement the total wall system withstood about 7,000 pounds, and the skins vertically sheared off the lathe. In the first case of complete confinement the wall failed at about 16,000 pounds and the skins remained in place with minor cracking. This specimen also continued to fall forward as greater load was applied. The second fully confined specimen tested did not reach failure in the lab. At a load of 20,000 pounds the specimen incurred little cracking in the plaster, and stood perfectly erect. The second specimen compares quite well with the highly reinforced specimen in Cale Ash's test which withstood 19kips.

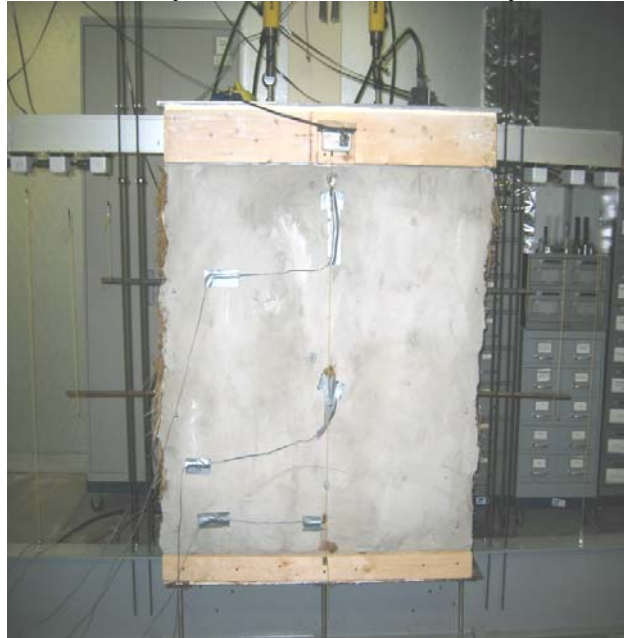
Figure 4.6 – Improved test setup with potentiometers attached to box beam

second test specimen had the potentiometers attached to the upper box beam of the wall instead of the testing frame (Figure 4.6), in an attempt to eliminate the bias incurred from the frame during the previous test. Despite the fact that the data did not come out as clear in the first test of complete confinement, there is assurance that the results for the second specimen, when made available, will be very accurate. Even without the exact load versus deflection pattern it is evident that the wall held substantially more than the moderately confined specimen.

Placing additional supports on the frame, kept the frame in place as load was applied to the wall. Having a steady setup applying load, allows the load to transfer directly into the wall and not to the frame. This test gives a more accurate picture of what a well confined wall can do. The moderately confined skins withstood 7kips on J-channel alone. This shows that J-channel is just the beginnings of obtaining a well built wall. Just the addition of one 2x4 tripled the holding capacity of the wall. This experiment only strengthens the reason why skins should be placed on the foundation of straw bale structures. Other methods to look into when testing plastered wall is placing the wall close to the ground, and letting the skins rest on the floor. A test of this nature would give the most realistic results compared to setting skins on the foundation on construction sites. Also conducting test with wall assemblies that have fully confined skin on one side and unconfined skin on the other, will give researchers an idea to how “half confinement” works compared to confinement of both sides. Results from a test of this kind can address the question, is there a possible long-run disadvantage to only confining interior skins, and if not what makes confining only one skin work? Until these questions are addressed the best and most reliable method of confining plastered skins is to place both skins on the foundation of the structure. So far this is the only full proof method of allowing the skins to transfer roof loads directly to the foundation.
