# **Compression load testing straw bale walls**

**Peter Walker**  
**Dept. Architecture & Civil Engineering**  
**University of Bath**  
**Bath**  
**BA2 7AY**

**May 2004**

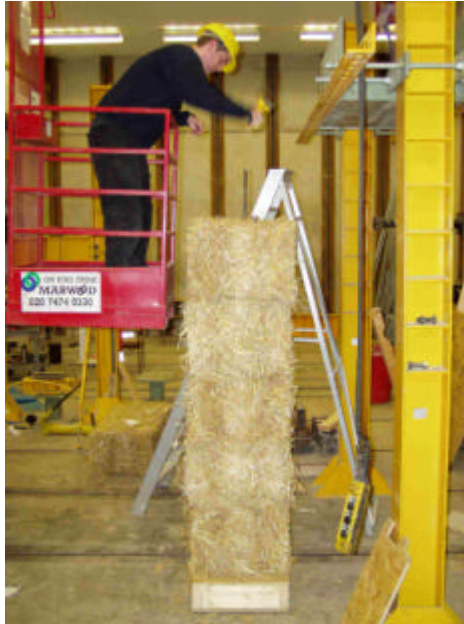
Figure 1 Wall construction

The straw bale walls were built on base plates formed from 150 mm x 50 mm softwood sections together with 18 mm OSB sheeting, figure 1. Loading was applied through a similar section wall plate. Both the base and wall plates were fabricated in accordance with recommendations of the UK guide for straw bale construction [3].

Bales were pinned vertically using 25-50 mm diameter fresh cut (green) hazel spikes. The spikes were sourced locally from hedge rows on the University of Bath's Claverton Down campus. Base (stub) pins (two per bale) were cut 250 mm long, with internal pins (also two per bale) nominally 1400 mm long.

The wall built with half bales showed a significant reduction in maximum load and initial stiffness. The half bales were not as dense as the original bales and the inclusion of vertical joints in alternative courses was also expected to impair stiffness and strength. Removal of hazel spikes from wall construction had a significant impact on both wall stiffness and load capacity, table 2. Hazel spikes contribute to wall resistance mainly through frictional resistance passing through the bales, as evident by the difficulty in driving them during construction, figure 1.

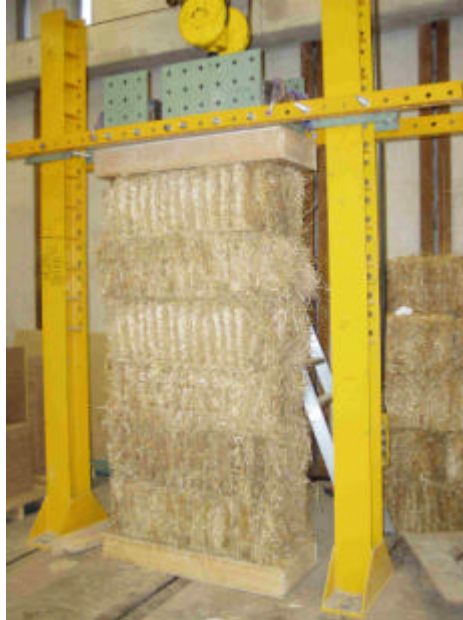
Figure 2 Settlement test set-up

In preparation for static testing to failure two of the test walls were subject to a dead loading of  $16.6 \text{ kN/m}^2$ , figure 2. Vertical settlement of the panels was measured periodically for up to 74 days. Results of these settlement tests are reported below.

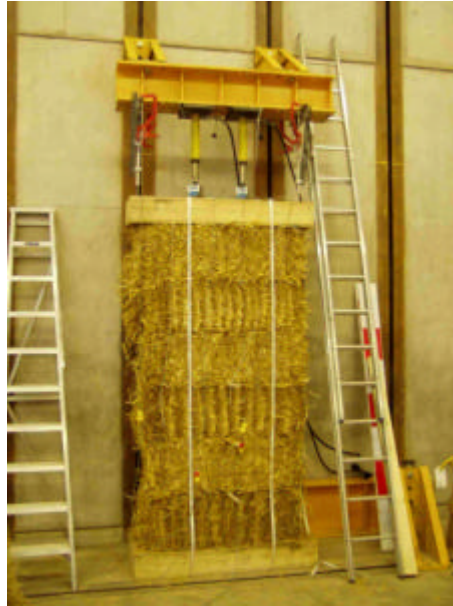
Figure 3 Static load test

All five wall panels were subject to static loading in vertical compression. Concentric loading was applied incrementally through two five tonne hydraulic jacks to failure, figure 3. The applied load was recorded using five-tonne digital load cells. The load was transferred directly to the straw bales through the timber wall plate. Vertical displacement of the straw bales was recorded using two linear voltage displacement transducers (LVDTs), placed centrally across the width of the plate, figure 3. Lateral buckling displacements under loading were also recorded using either LVDTs or by direct taping measurement. The average incremental rate of loading to failure was between  $0.30$  and  $0.73 \text{ kN/min}$ . In between each increment lateral displacement was measured by taping and noting the general condition of the wall.

In the second test a total service loading of 840 kg was applied in one increment. The initial stiffness of the wall, 17 kN/mm, was similar to the first test wall response. As before the deformation increased with time. The greatest rate of creep deformation was also recorded during the first two days after loading and thereafter the rate of settlement was approximately 0.5 mm/day over the following three weeks. Settlement of the wall had not ceased after 23 days when the test was ended. The wall was subsequently strapped with polypropylene strapping, figure 3, and lime rendered before load testing to failure.

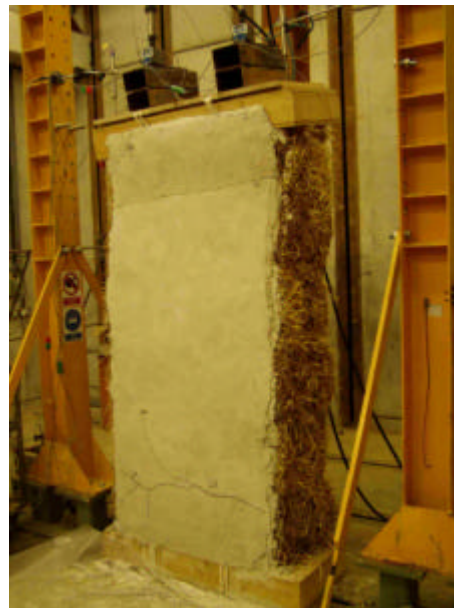
Figure 8 Lime rendered wall failure

Lime rendering of the wall had greatest impact on strength and stiffness. Initial stiffness was increased by over 50 times and the maximum applied load by nearly 50%. Stiffness of the wall under load decreased noticeably at around 15 kN as the

lime render cracked. The wall failed as a result of the lime render separating from the straw on one side beneath the top plate. Though the lime render was applied to the straw bales outside the full width of the top bearing plate, a slight bearing of the top plate onto the edge of the render of one side resulted in unequal settlement of the top plate, figure 8, contributing to the observed failure mode. Other failure modes reported for rendered walls include overall buckling of the wall, local buckling of the plaster, and bearing failure of the plaster [2].
