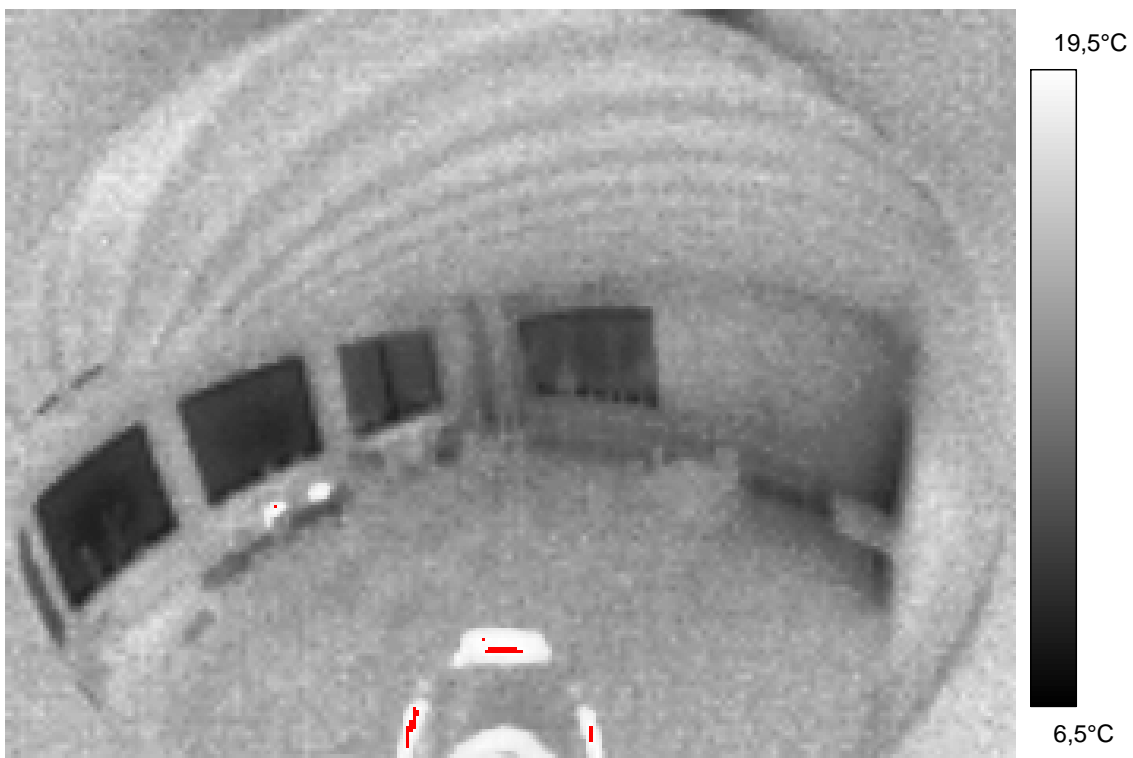
9 - Ir_1249.jpg

Lecture hall in a concave mirror, image taken from its NE corner.

Label	Value
IR : max	22,8°C
IR : min	13,1°C

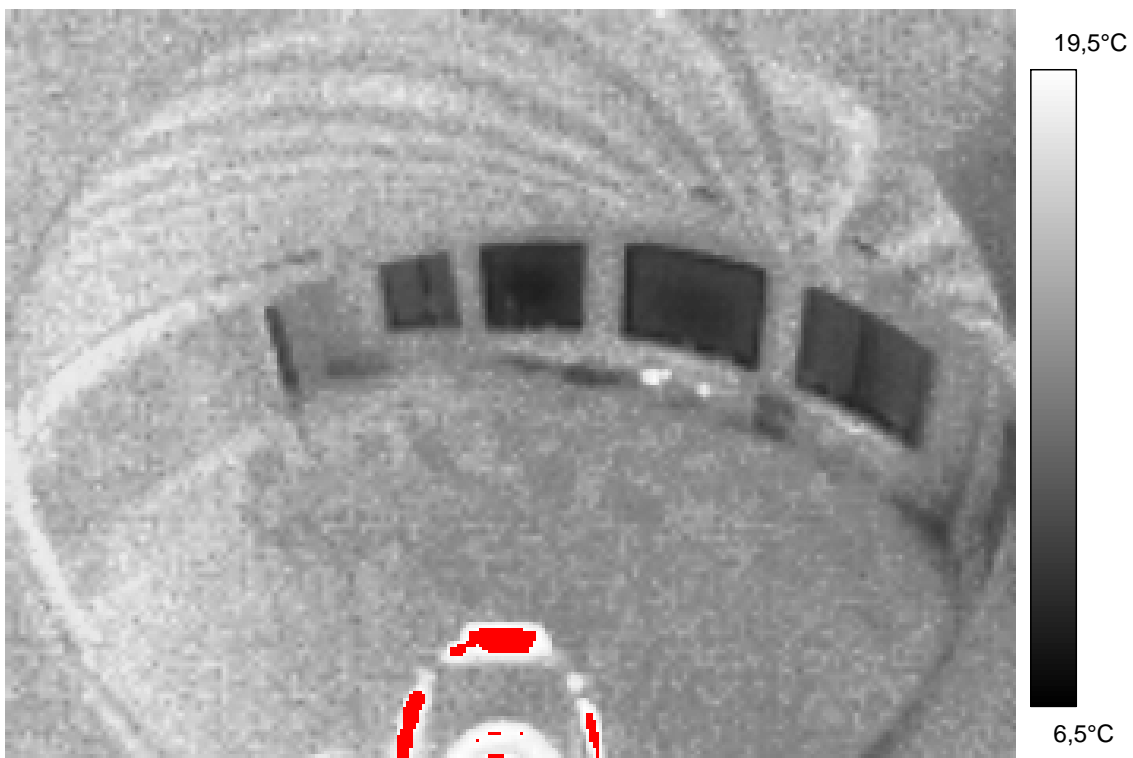
11 - Ir_1251.jpg

Mirror view from the SE corner.

Label	Value
IR : max	24,7°C
IR : min	13,0°C

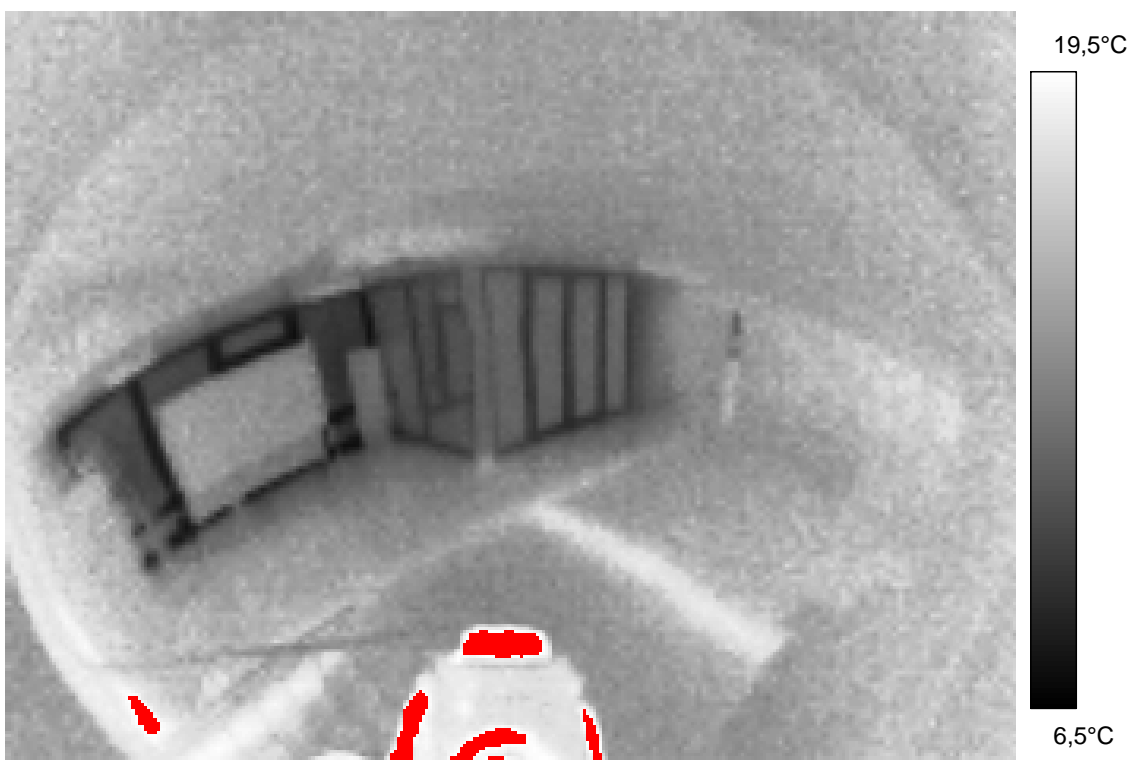
13 - Ir_1253.jpg

Taken from the NE corner. Warm area at left, in front of glazing, is a large poster. May be used as a reference temp. ground,

Label	Value
IR : max	27,6°C
IR : min	9,7°C

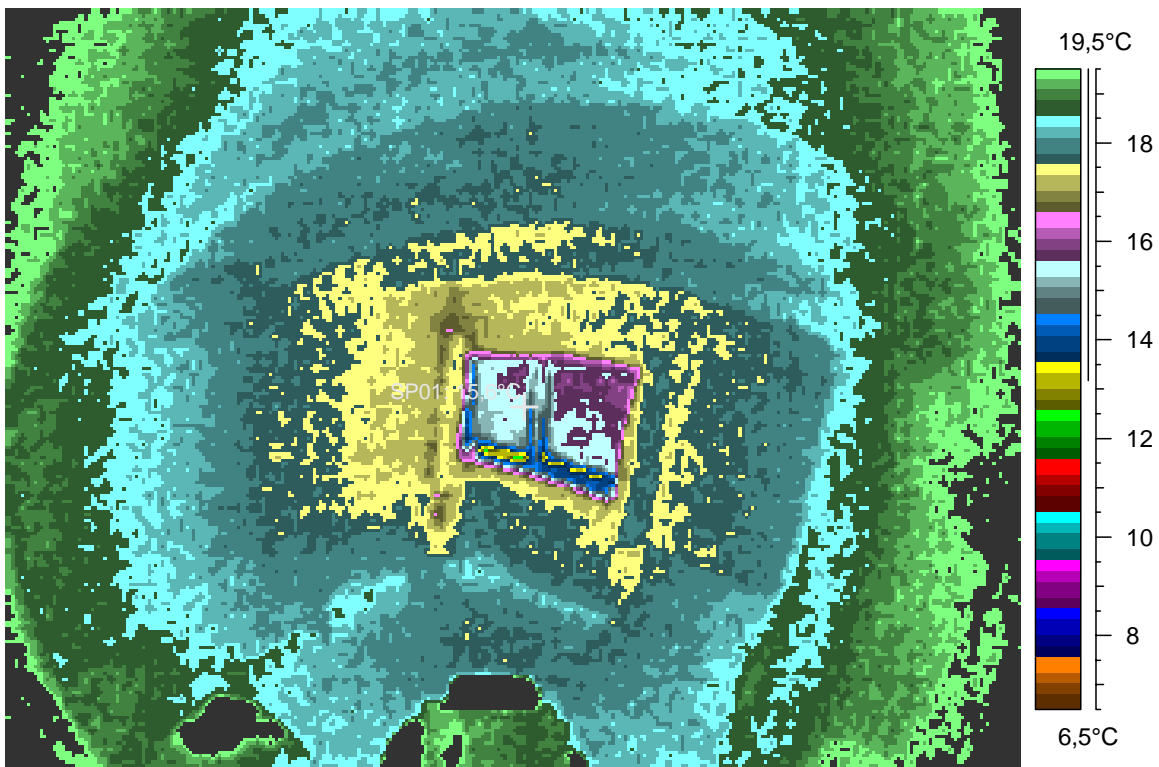
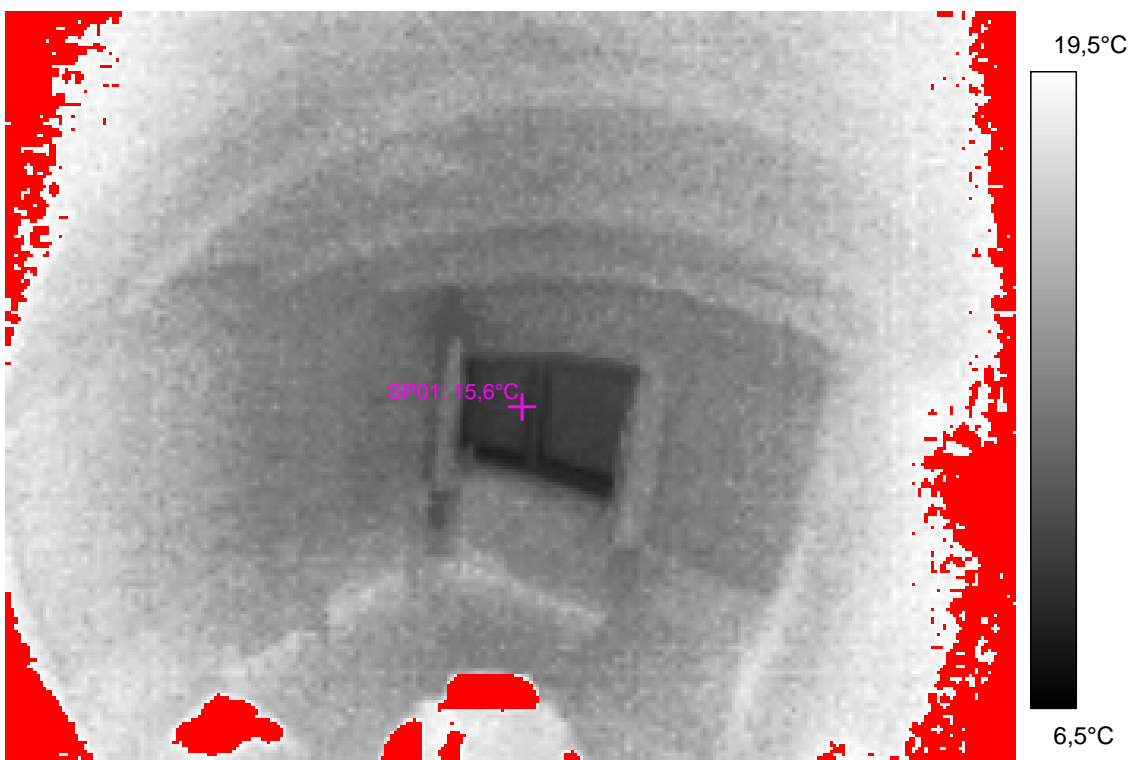
36 - Ir_1276.jpg

The same room, from its very corner.

Label	Value
IR : max	31,5°C
IR : min	12,5°C
SP01	15,6°C
