LOAD-BEARING STRAW BALE CONSTRUCTION

A summary of worldwide testing and experience

June 30, 2003

Bruce King, PE

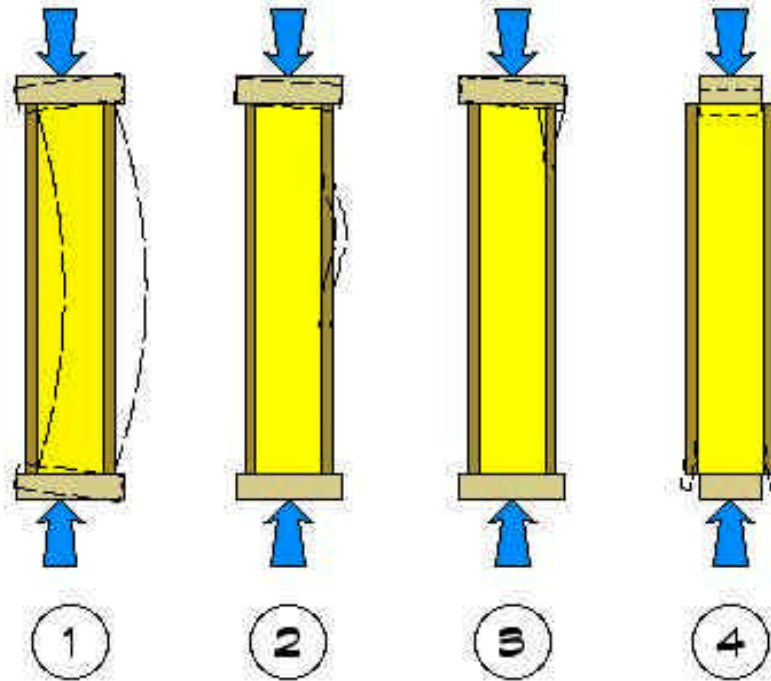
Figure 2: Failure modes for a load-bearing straw bale wall

Under vertical load, there are four basic types of failure modes, and the tests conducted to date have seen each and all, either singly or in combination:

- 1. Global buckling** the whole wall bends and breaks—typically when the wall is well-built, but eccentrically applied load induces bending.
- 2. Local buckling** part of the skin delaminates and pulls off the core, or one coat of plaster delaminates and separates from the coat beneath—the result of poor plaster application causing insufficient bond, and/or surface irregularity causing local bending.
- 3. Bearing** skin crushes under the top or bottom plate, and/or top or bottom plate crushes under edge of skin—the wall components have not been designed or built to sustain the focused stress at the joint.
- 4. Slippage** unsupported skin slips past the top or bottom plate—typically, a failure of fasteners attaching mesh to the sides of plates or beams.

Notes: It has been widely noted that, contrary to expectation, the 18" walls carried substantially more load than the 24" walls, and were stiffer. Though there were some irregularities in load application, and in the quality of plastering, this dramatic difference has yet to be fully explained or understood. Every possible failure mode was seen among the nine specimens (see figure 2),
